Royal South Hants Hospital

Type 2 Asbestos Survey Report – Copy 1

November 2009

S-31559 / BI61109AW1 / Issue No. 2

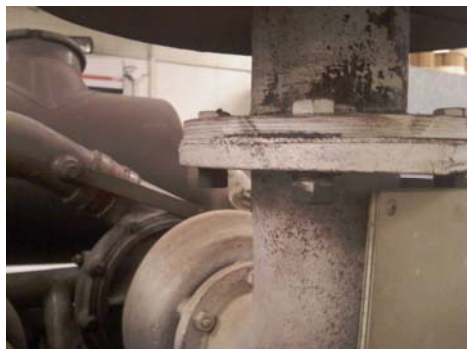
Sample No.	Item Description	Item Extent	Comments / Observations / Recommendation			
A276582/021	Rope gasket to exhaust	0.2m	ENCAPSULATE & MANAGE			
Analysis	Product Type		Hazard Risk Assessment			
Chrysotile	Asbestos insulating board, millboards, gaskets & ropes etc.		Material Score		Priority Score

Product Type	2	Normal Occupant Activity	I
			Condition	I	Likelihood of Disturbance	I
			Treatment	2	Human Exposure Potential	I
			Asbestos Type	I	Maintenance Activity	I
			Total	6	Total	4
			Overall Score:		10

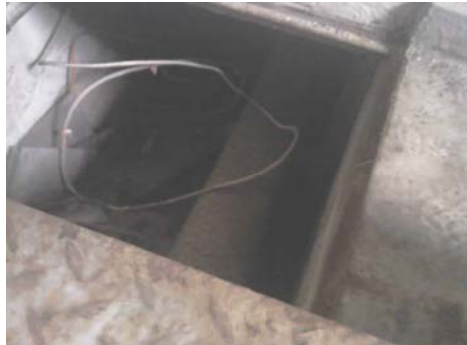
Sample No.	Item Description	Item Extent	Comments / Observations / Recommendation			
A276580/019	Wrap to pipe	4m				
Analysis	Product Type		Hazard Risk Assessment			
NAD	N/A		Material Score		Priority Score

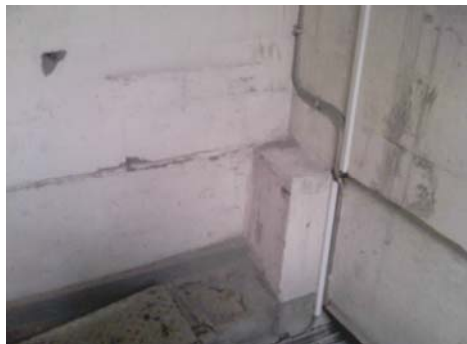
Sample No.	Item Description	Item Extent	Comments / Observations / Recommendation			
A276581/020	Residue to wall	2m²				
Analysis	Product Type		Hazard Risk Assessment			
NAD	N/A		Material Score		Priority Score

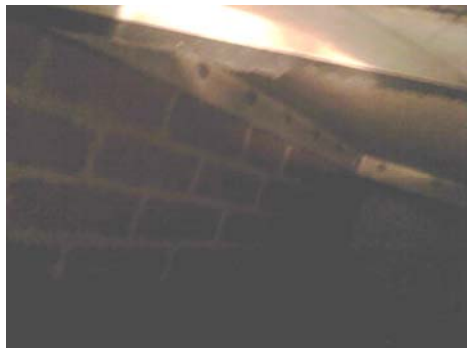
Sample No.	Item Description	Item Extent	Comments / Observations / Recommendation			
A276583/022	Bitumen under tank	4m ²				
Analysis	Product Type		Hazard Risk Assessment			
NAD	N/A		Material Score		Priority Score

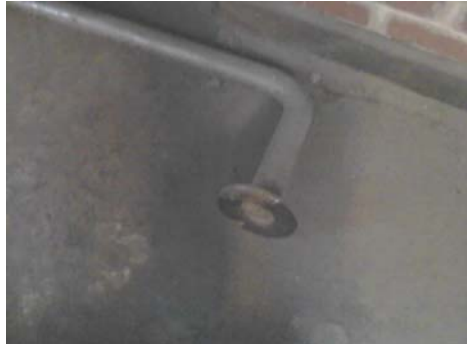
Sample No.	Item Description	Item Extent	Comments / Observations / Recommendation			
A276584/023	Gasket on redundant pipe	0.2m ²				
Analysis	Product Type		Hazard Risk Assessment			
NAD	N/A		Material Score		Priority Score

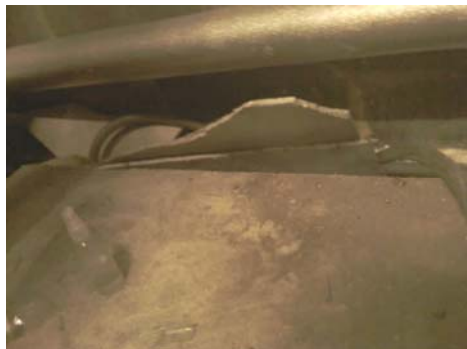
Sample No.	Item Description	Item Extent	Comments / Observations / Recommendation			
A276576/015	Ceiling panel on the floor	0.5m²				
Analysis	Product Type		Hazard Risk Assessment			
NAD	N/A		Material Score		Priority Score

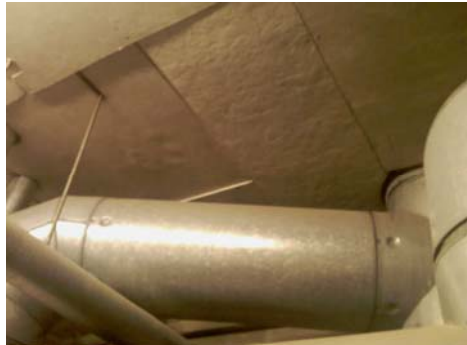
Sample No.	Item Description	Item Extent	Comments / Observations / Recommendation			
A276577/016	Ceiling panel	12m²				
Analysis	Product Type		Hazard Risk Assessment			
NAD	N/A		Material Score		Priority Score

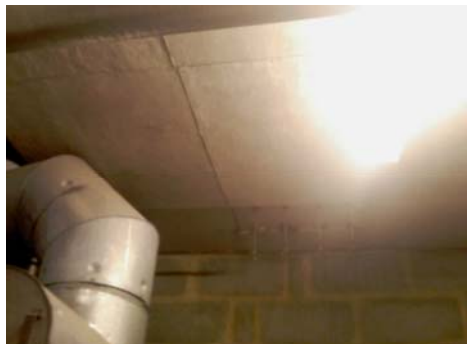
Sample No.	Item Description	Item Extent	Comments / Observations / Recommendation			
A276578/017	Ceiling panel	12m ²				
Analysis	Product Type		Hazard Risk Assessment			
NAD	N/A		Material Score		Priority Score

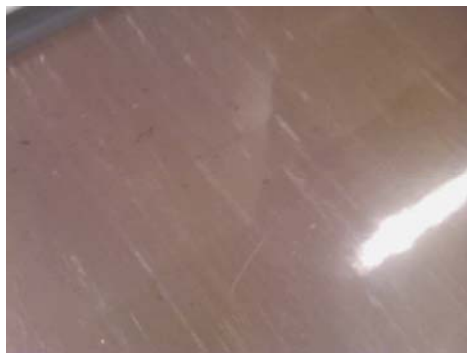
Product Type	1	Normal Occupant Activity	2
			Condition	0	Likelihood of Disturbance	2
			Treatment	0	Human Exposure Potential	2
			Asbestos Type	1	Maintenance Activity	0
			Total	2	Total	6
			Overall Score:		8

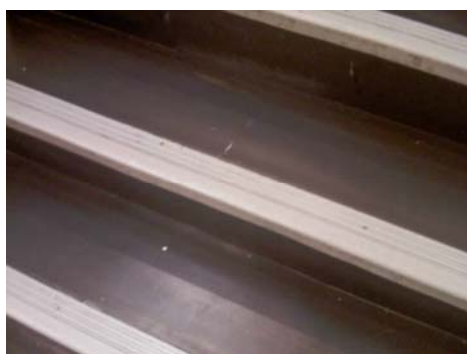
Product Type	1	Normal Occupant Activity	2
			Condition	0	Likelihood of Disturbance	2
			Treatment	0	Human Exposure Potential	2
			Asbestos Type	1	Maintenance Activity	0
			Total	2	Total	6
			Overall Score:		8

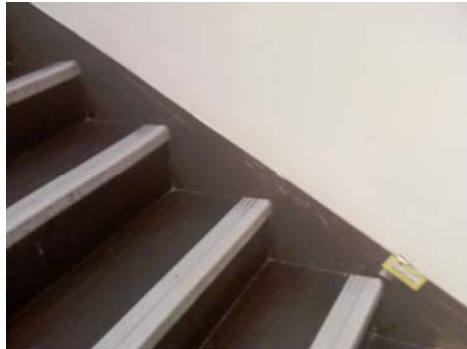
Product Type	1	Normal Occupant Activity	2
			Condition	0	Likelihood of Disturbance	2
			Treatment	0	Human Exposure Potential	2
			Asbestos Type	1	Maintenance Activity	0
			Total	2	Total	6
			Overall Score:		8

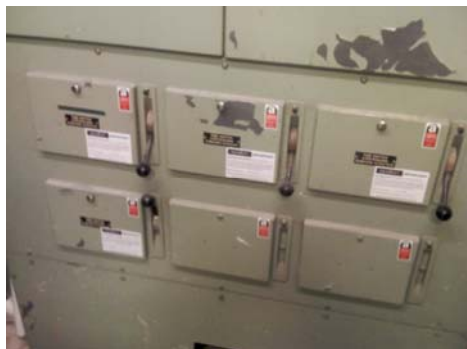
Product Type	2	Normal Occupant Activity	1
			Condition	1	Likelihood of Disturbance	1
			Treatment	1	Human Exposure Potential	2
			Asbestos Type	1	Maintenance Activity	1
			Total	5	Total	5
			Overall Score:		10

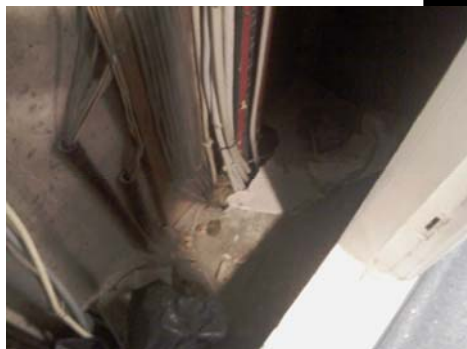
Product Type		2	Normal Occupant Activity	1	
	Condition		3	Likelihood of Disturbance	1	
	Treatment		2	Human Exposure Potential	0	
	Asbestos Type		2	Maintenance Activity	0	
	Total		9	Total	2	
	<u>Overall Score:</u>			<u>11</u>

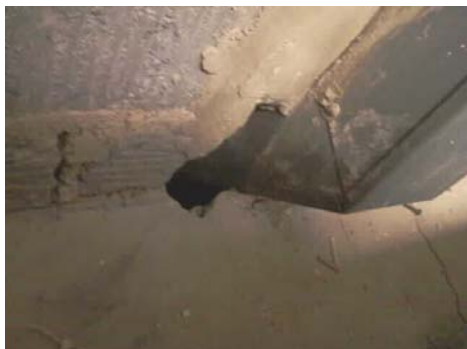
Product Type	2	Normal Occupant Activity	1
			Condition	1	Likelihood of Disturbance	1
			Treatment	2	Human Exposure Potential	0
			Asbestos Type	2	Maintenance Activity	0
			Total	7	Total	2
			Overall Score:		9

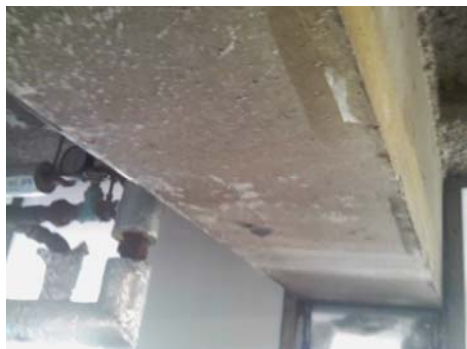
Product Type	3	Normal Occupant Activity	1	
			Condition	3	Likelihood of Disturbance	1	
			Treatment	3	Human Exposure Potential	1	
			Asbestos Type	1	Maintenance Activity	1	
			Total	10	Total	4	
			Overall Score:		14

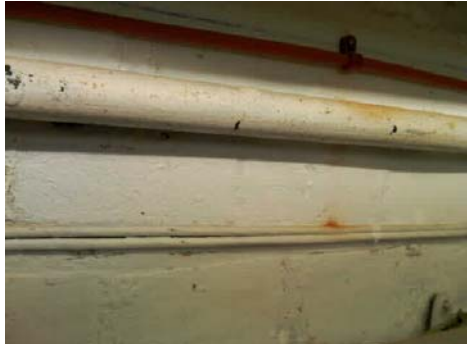
Product Type	3	Normal Occupant Activity	1
			Condition	3	Likelihood of Disturbance	1
			Treatment	3	Human Exposure Potential	1
			Asbestos Type	3	Maintenance Activity	0
			Total	12	Total	3
			Overall Score:		15

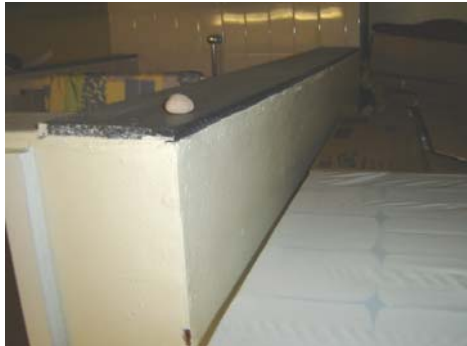
Product Type	1	Normal Occupant Activity	0
			Condition	0	Likelihood of Disturbance	2
			Treatment	0	Human Exposure Potential	1
			Asbestos Type	1	Maintenance Activity	1
			Total	2	Total	4
			Overall Score:		6

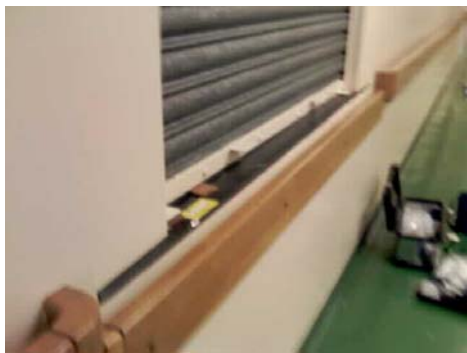
Product Type	1	Normal Occupant Activity	2
			Condition	1	Likelihood of Disturbance	1
			Treatment	0	Human Exposure Potential	2
			Asbestos Type	1	Maintenance Activity	0
			Total	3	Total	5
			Overall Score:		8
