Asbestos Management Plan
For
Wembley Centre for Health Care
For
NHS Property Services
December 2013

WYG Asbestos Reinspection Survey Report

19 Jul 2013

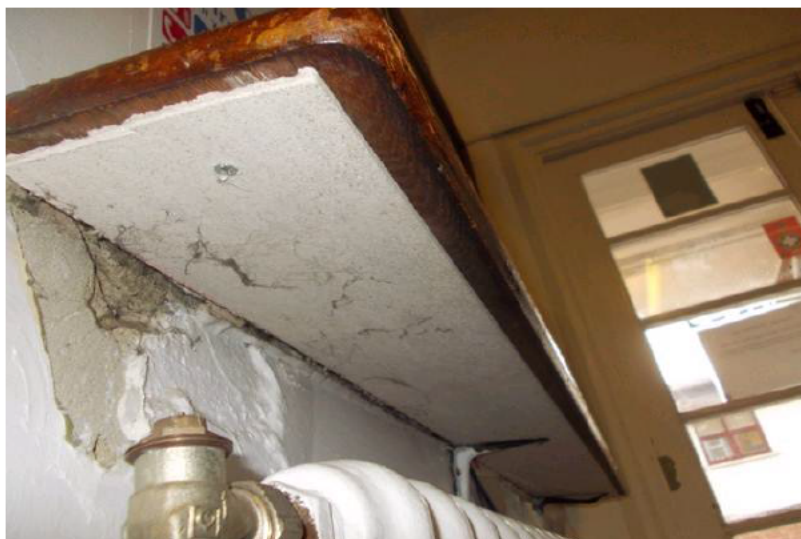
Inspection Number	1	Reference Number:	N/A
Inspection / Sample	Visual Inspection	Inspection Cross Reference / Visual I.D.	N.A.D.I.S

Notes	Cement removed and replaced with modern insulating board
-------	--

Building	Dental administration
Floor Level	Ground Floor
Area / Room	1 Entrance hall
Feature	Cement panel above radiator
Product Type	Not applicable (No detected)
Extent Amount	< 1 m ²

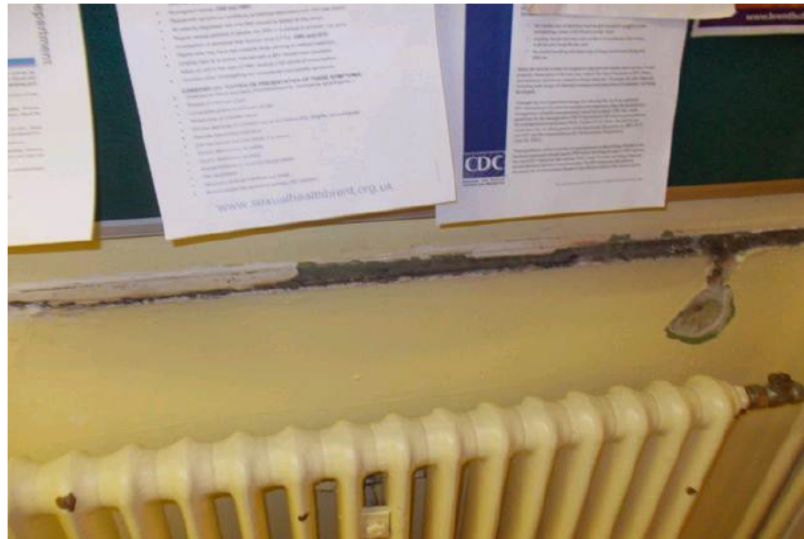
Inspection Number	2	Reference Number:	N/A
Inspection / Sample	Visual Inspection	Inspection Cross Reference / Visual I.D.	N.A.D.I.S

Notes	Whole shelf removed
-------	---------------------

Building	Dental administration
Floor Level	Ground Floor
Area / Room	0 Corridor
Feature	Cement panel above radiator
Product Type	Not applicable (No detected)
Extent Amount	< 1 m ²

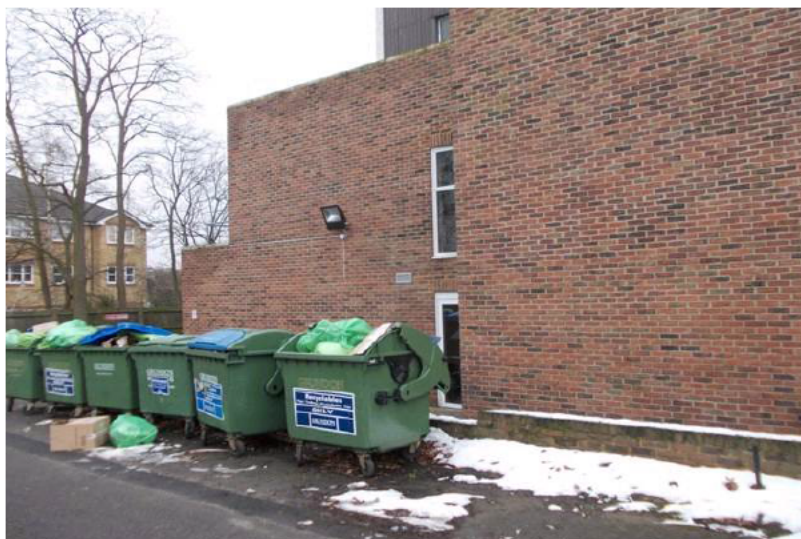
Inspection Number	3	Reference Number:	N/A
Inspection / Sample	Visual Inspection	Inspection Cross Reference / Visual I.D.	N.A.D.I.S

Notes	Plant room demolished
-------	-----------------------

Building	Dental administration
Floor Level	Ground Floor
Area / Room	1 Plant room 1
Feature	Gaskets to pipework
Product Type	Not applicable (No detected)
Extent Amount	1 m ²

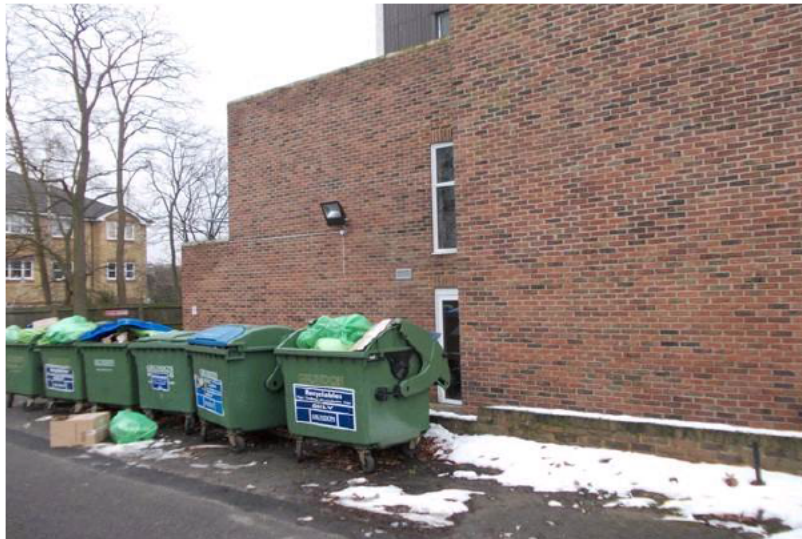
Inspection Number	4	Reference Number:	N/A
Inspection / Sample	Visual Inspection	Inspection Cross Reference / Visual I.D.	N.A.D.I.S

Notes	Plant room demolished
-------	-----------------------

Building	Dental administration
Floor Level	Ground Floor
Area / Room	1 Plant room 1
Feature	Cloth insulation
Product Type	Not applicable (No detected)
Extent Amount	1 m ²

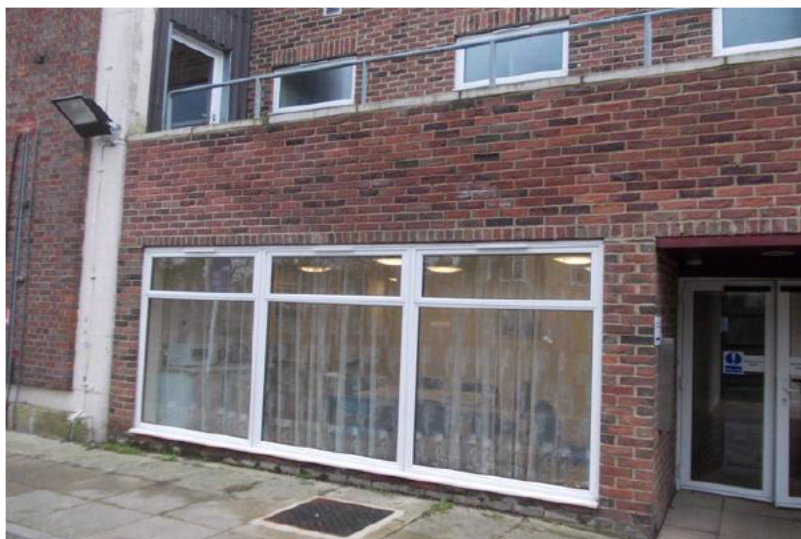
Inspection Number	5	Reference Number:	N/A
Inspection / Sample	Visual Inspection	Inspection Cross Reference / Visual I.D.	N.A.D.I.S

Notes	Plant room demolished
-------	-----------------------

Building	Dental administration
Floor Level	Ground Floor
Area / Room	00 Plant room 2
Feature	Insulation residue
Product Type	Not applicable (No detected)
Extent Amount	1 m ²

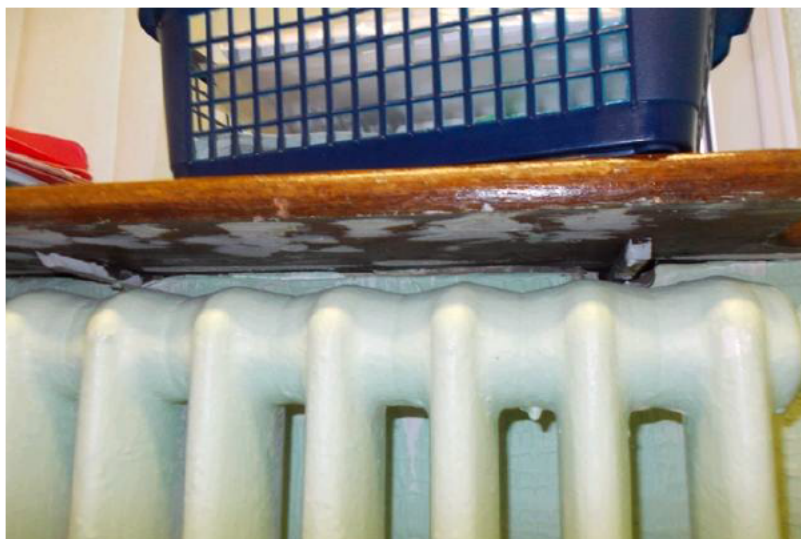
Inspection Number	6	Reference Number:	N/A
Inspection / Sample	Visual Inspection	Inspection Cross Reference / Visual I.D.	N.A.D.I.S

Notes	Cement panel removed
-------	----------------------

Building	Dental administration
Floor Level	Ground Floor
Area / Room	02 Store
Feature	Cement panel above radiator
Product Type	Not applicable (No detected)
Extent Amount	< 1 m ²

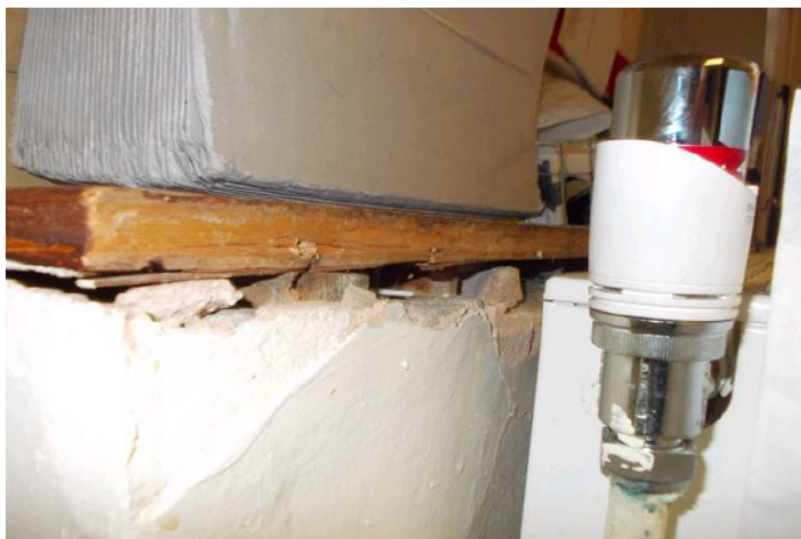
Inspection Number	7	Reference Number:	N/A
Inspection / Sample	Visual Inspection	Inspection Cross Reference / Visual I.D.	N.A.D.I.S

Notes	Cement panel removed
-------	----------------------

Building	Dental administration
Floor Level	Ground Floor
Area / Room	05 and 06 Office
Feature	Cement panel above radiator
Product Type	Not applicable (No detected)
Extent Amount	4 no.

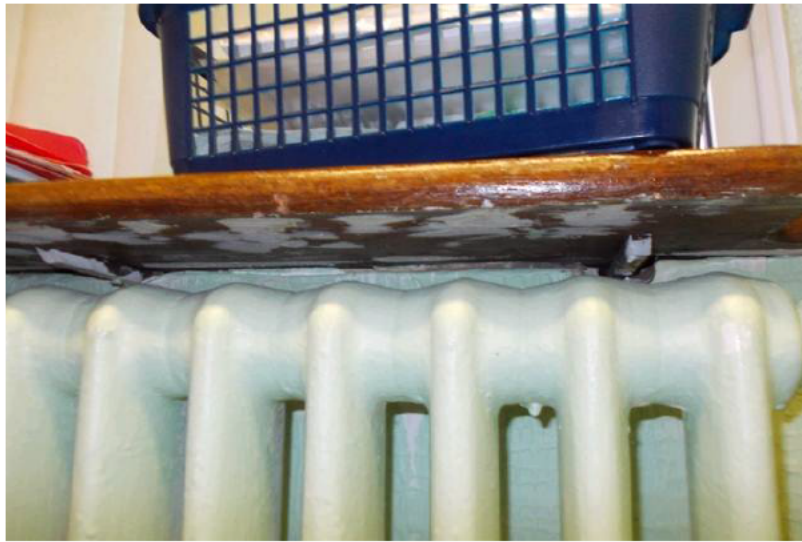
Inspection Number	8	Reference Number:	N/A
Inspection / Sample	Visual Inspection	Inspection Cross Reference / Visual I.D.	N.A.D.I.S

Notes	Cement panel removed
-------	----------------------

Building	Dental administration
Floor Level	Ground Floor
Area / Room	11 Office
Feature	Cement panel above radiator
Product Type	Not applicable (No detected)
Extent Amount	2 no.

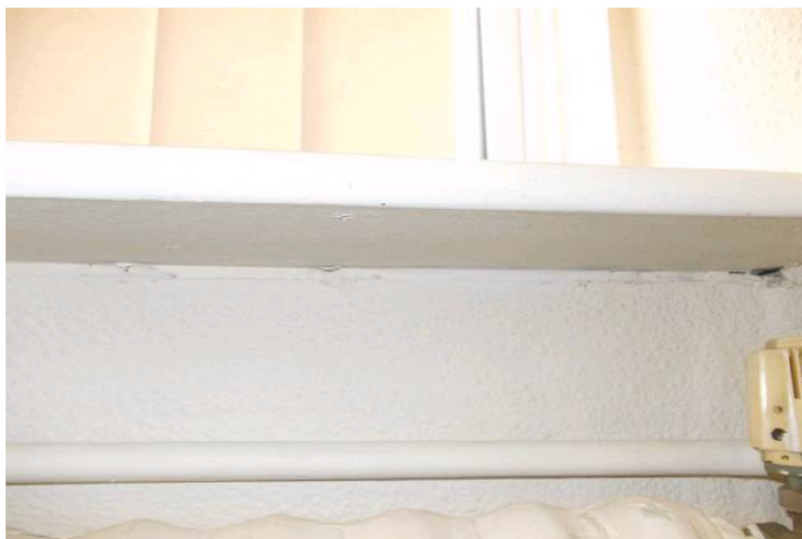
Inspection Number	9	Reference Number:	N/A
Inspection / Sample	Visual Inspection	Inspection Cross Reference / Visual I.D.	N.A.D.I.S

Notes	Cement panel removed
-------	----------------------

Building	Dental administration
Floor Level	Ground Floor
Area / Room	12 Office
Feature	Cement panel above radiator
Product Type	Not applicable (No detected)
Extent Amount	1 no.

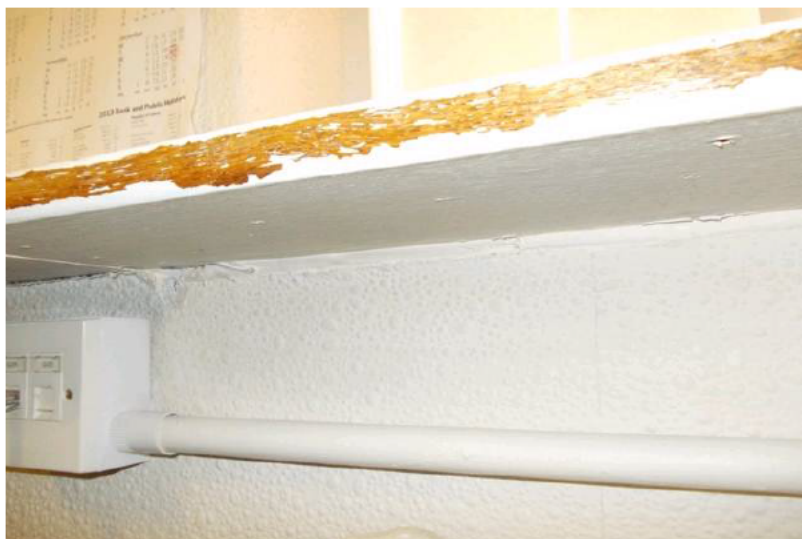
Inspection Number	10	Reference Number:	N/A
Inspection / Sample	Visual Inspection	Inspection Cross Reference / Visual I.D.	N.A.D.I.S

Notes	Cement panel removed
-------	----------------------

Building	Dental administration
Floor Level	Ground Floor
Area / Room	13 Office
Feature	Cement panel above radiator
Product Type	Not applicable (No detected)
Extent Amount	1 no.

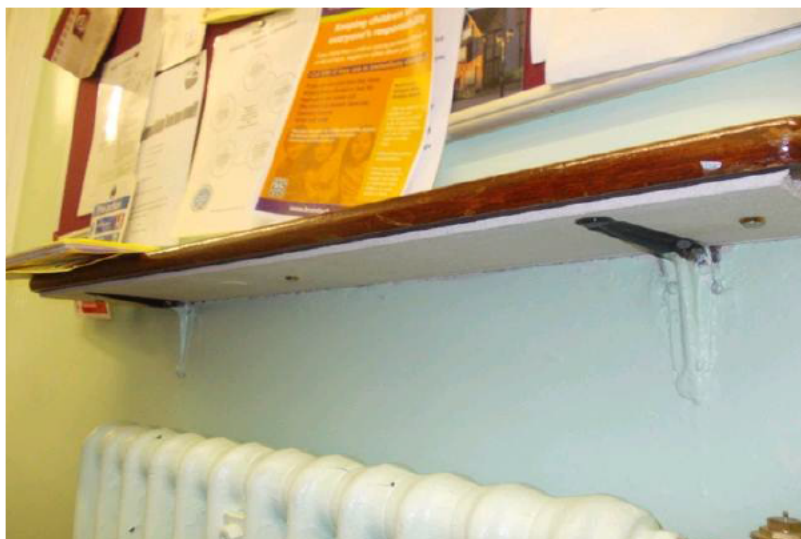
Inspection Number	11	Reference Number:	N/A
Inspection / Sample	Visual Inspection	Inspection Cross Reference / Visual I.D.	N.A.D.I.S

Notes	Cement panel removed and replaced with modern insulating board
-------	--

Building	Dental administration
Floor Level	1st Floor
Area / Room	1 Corridor
Feature	Cement panel above radiator
Product Type	Not applicable (No detected)
Extent Amount	2 no.

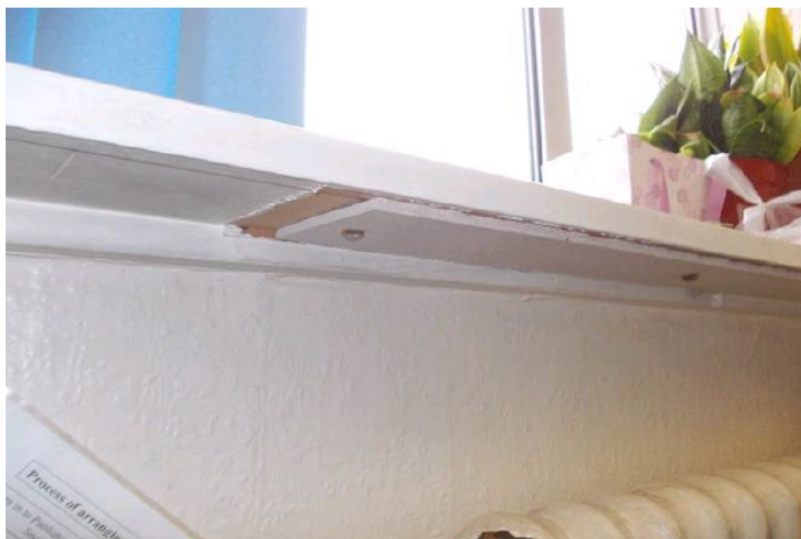
Inspection Number	12	Reference Number:	N/A
Inspection / Sample	Visual Inspection	Inspection Cross Reference / Visual I.D.	N.A.D.I.S

Notes	Cement panel removed and replaced with modern insulating board
-------	--

Building	Dental administration
Floor Level	1st Floor
Area / Room	A1 Room
Feature	Cement panel above radiator
Product Type	Not applicable (No detected)
Extent Amount	1 no.

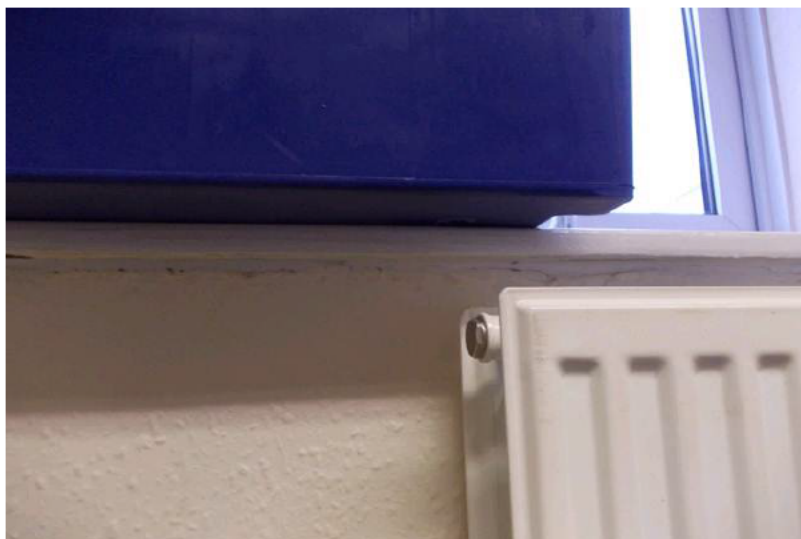
Inspection Number	13	Reference Number:	N/A
Inspection / Sample	Visual Inspection	Inspection Cross Reference / Visual I.D.	N.A.D.I.S

Notes	Cement panel removed
-------	----------------------

Building	Dental administration
Floor Level	1st Floor
Area / Room	A16 Room
Feature	Cement panel above radiator
Product Type	Not applicable (No detected)
Extent Amount	3 no.

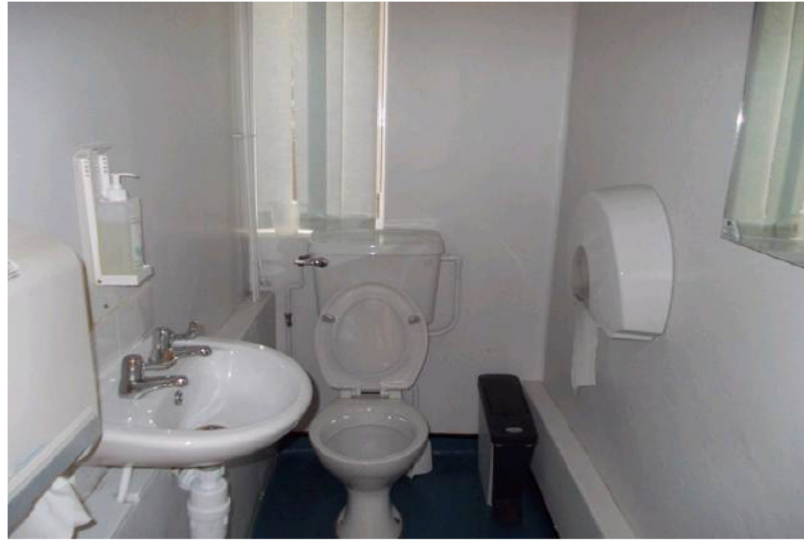
Inspection Number	14	Reference Number:	N/A
Inspection / Sample	Visual Inspection	Inspection Cross Reference / Visual I.D.	N.A.D.I.S

Building	Old hospital
Floor Level	Ground Floor
Area / Room	094 W/c
Feature	Toilet cistern
Product Type	Not applicable (No detected)
Extent Amount	1 no.

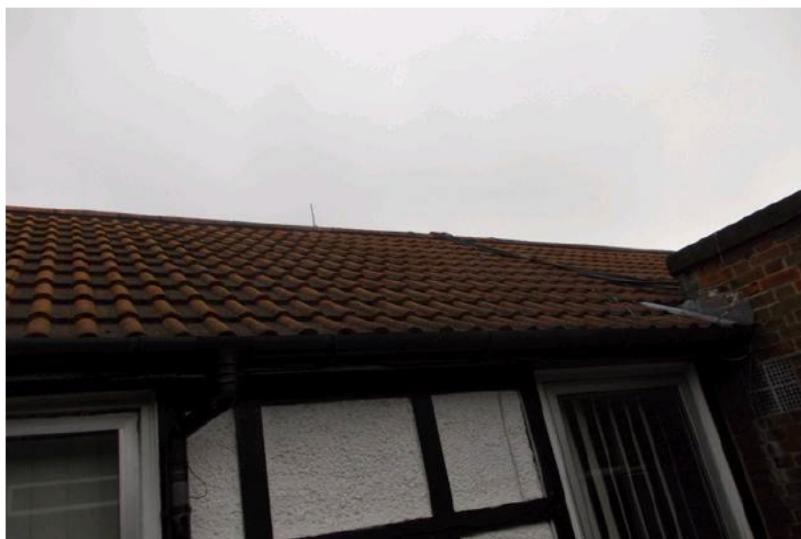
Inspection Number	15	Reference Number:	N/A
Inspection / Sample	Visual Inspection	Inspection Cross Reference / Visual I.D.	Asbestos Presumed

Building	Old hospital
Floor Level	Ground Floor
Area / Room	2 Fairview offices roof
Feature	Roof slates
Product Type	Asbestos Cement
Extent Amount	180 m ²

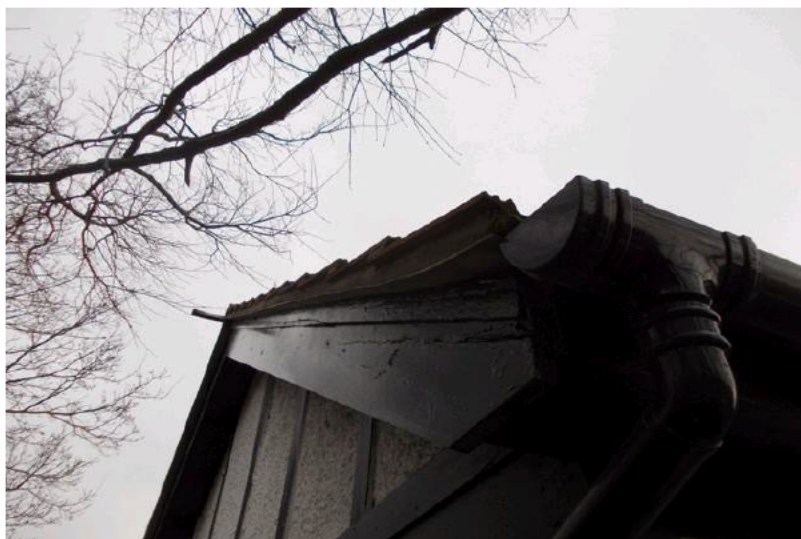
Inspection Number	16	Reference Number:	N/A
Inspection / Sample	Visual Inspection	Inspection Cross Reference / Visual I.D.	Asbestos Presumed

Building	Old hospital
Floor Level	Ground Floor
Area / Room	2 Fairview offices roof
Feature	Undercloak edging to gable
Product Type	Asbestos Cement
Extent Amount	30 m

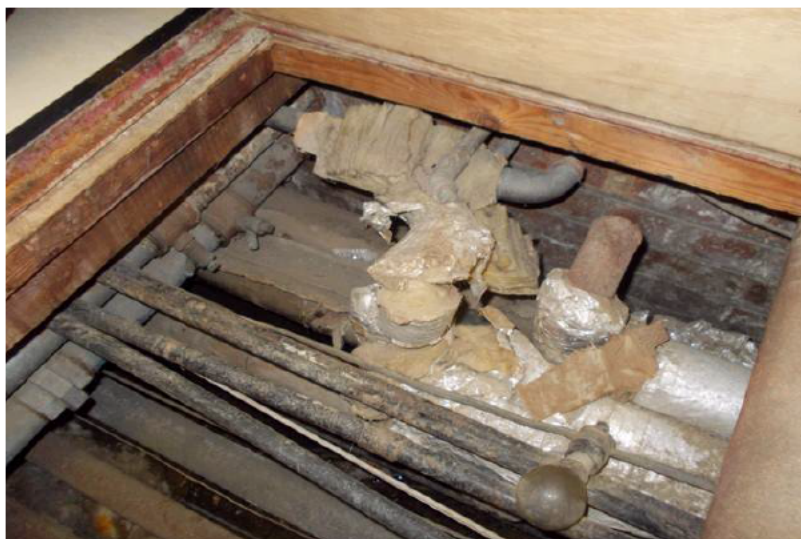
Inspection Number	17	Reference Number:	N/A
Inspection / Sample	Visual Inspection	Inspection Cross Reference / Visual I.D.	Asbestos Presumed

Notes	Presume still present until shown otherwise
-------	---

Building	Old hospital
Floor Level	Ground Floor
Area / Room	0 Main corridor
Feature	Debris on pipe
Product Type	Asbestos Insulation/Coating
Extent Amount	< 1 m ²

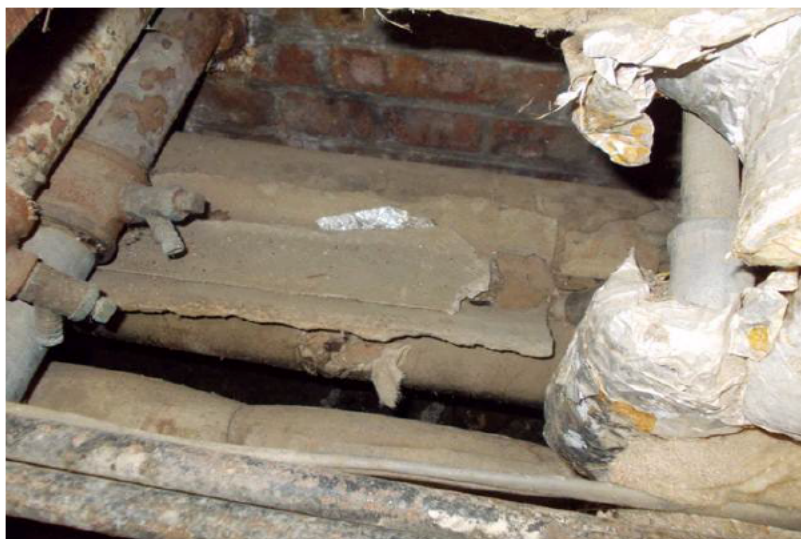
Inspection Number	18	Reference Number:	N/A
Inspection / Sample	Visual Inspection	Inspection Cross Reference / Visual I.D.	Asbestos Presumed

Notes	Debris still clearly visible
-------	------------------------------

Building	Old hospital
Floor Level	Ground Floor
Area / Room	0 Main corridor
Feature	Cement debris within duct
Product Type	Asbestos Cement
Extent Amount	1 m ²

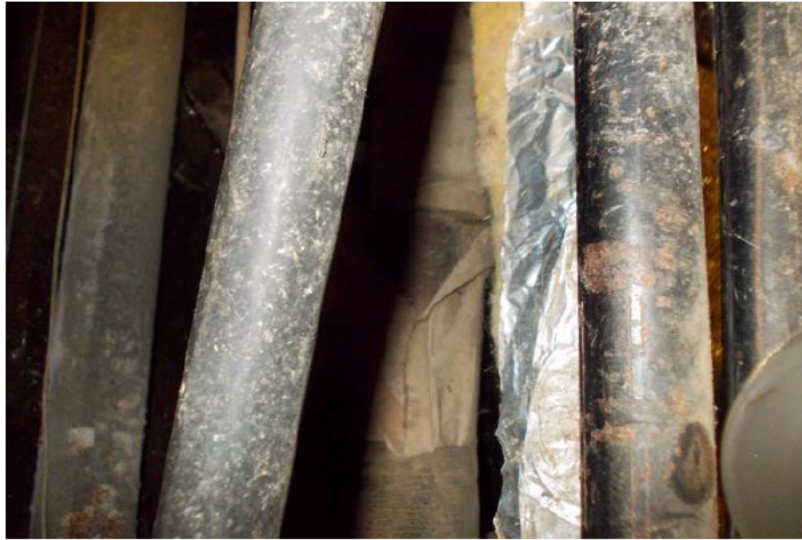
Inspection Number	19	Reference Number:	N/A
Inspection / Sample	Visual Inspection	Inspection Cross Reference / Visual I.D.	Asbestos Presumed

Notes	Presume still present until shown otherwise
-------	---

Building	Old hospital
Floor Level	Ground Floor
Area / Room	0 Main corridor
Feature	Paper wrap to pipe beneath mmmf insulation within duct
Product Type	Asbestos Textiles/Paper
Extent Amount	2 m

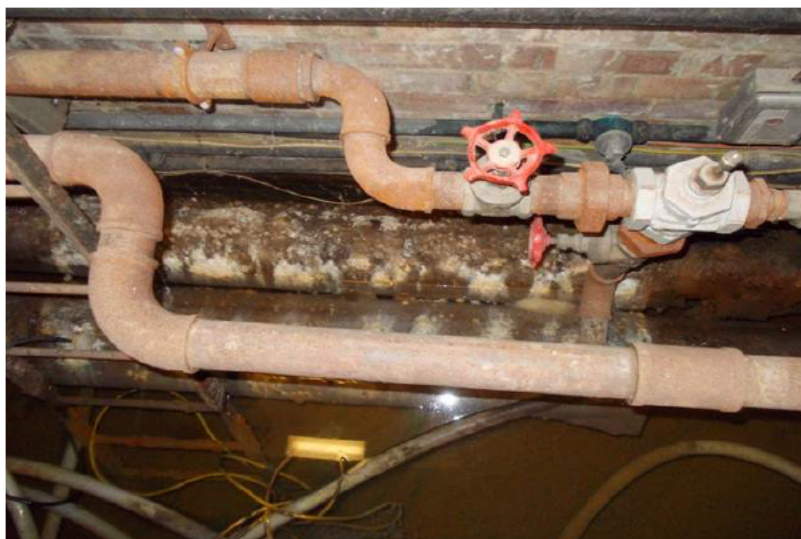
Inspection Number	20	Reference Number:	N/A
Inspection / Sample	Visual Inspection	Inspection Cross Reference / Visual I.D.	Asbestos Presumed

Notes	Presume still present until shown otherwise
-------	---

Building	Old hospital
Floor Level	Ground Floor
Area / Room	0 Main corridor
Feature	Paper wrap to pipe beneath mmmf insulation within duct
Product Type	Asbestos Textiles/Paper
Extent Amount	2 m

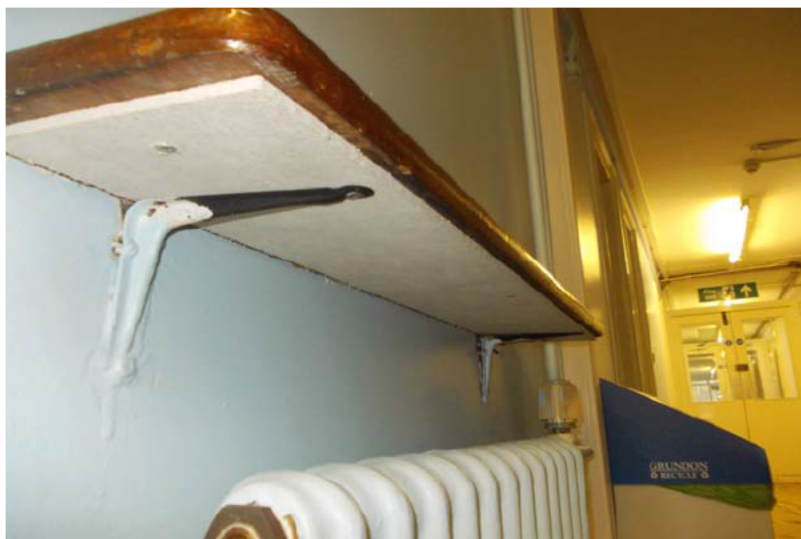
Inspection Number	21	Reference Number:	N/A
Inspection / Sample	Visual Inspection	Inspection Cross Reference / Visual I.D.	N.A.D.I.S

Notes	Removed and replaced with modern insulating board
-------	---

Building	Dental administration
Floor Level	2nd Floor
Area / Room	Corridor
Feature	Cement panel above radiator
Product Type	Not applicable (No detected)
Extent Amount	1 m

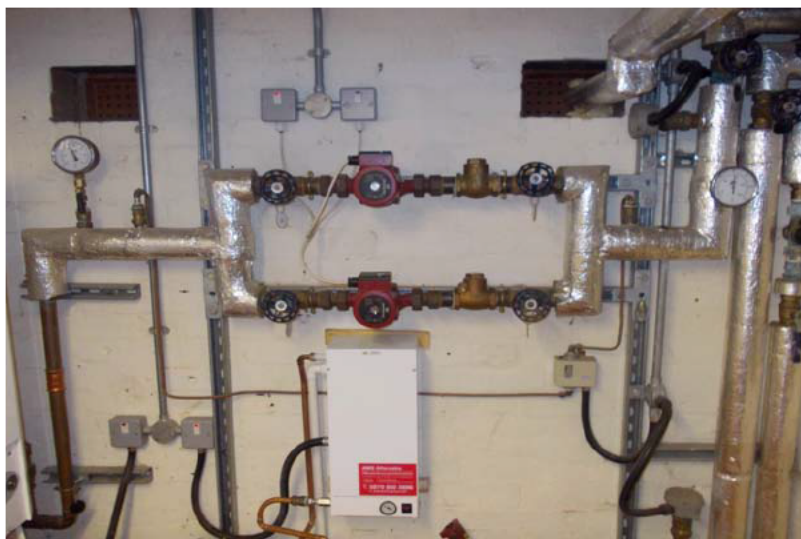
Inspection Number	22	Reference Number:	N/A
Inspection / Sample	Visual Inspection	Inspection Cross Reference / Visual I.D.	N.A.D.I.S

Notes	Item removed - area refurbished
-------	---------------------------------

Building	Old hospital
Floor Level	Ground Floor
Area / Room	151 Bunker plant room
Feature	Textile fuse lining
Product Type	Textiles/Paper
Extent Amount
