Wembley Centre for Health Care

Asbestos Register – Copy 1

Kensington and Chelsea NHS Primary Care Trust

Name of Site:	Wembley Centre for Health Care
Address of Site:	116, Chaplin Road, Wembley, Middlesex HA0 4UZ
Type of Survey:	Type 2
Survey Commissioned by:	Kensington & Chelsea NHS Primary Care Trust
Date of Survey:	28 th January 2003
R. A. Job No:	L2835

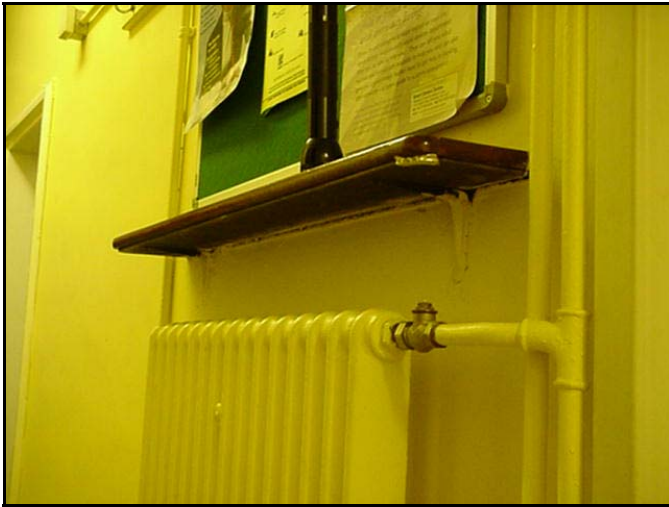
Sample No.	Photo ref.	Material Description	Material Extent	Analysis	Classification	Hazard	Comments & Recommendations
A65830/11	4.1	Panel under Shelf	1 m ²	Chrysotile	Asbestos cement products	D	This panel is encapsulated in a good condition. This panel should be labelled as asbestos to help prevent any accidental damage.

4.1 Asbestos cement panel under shelf

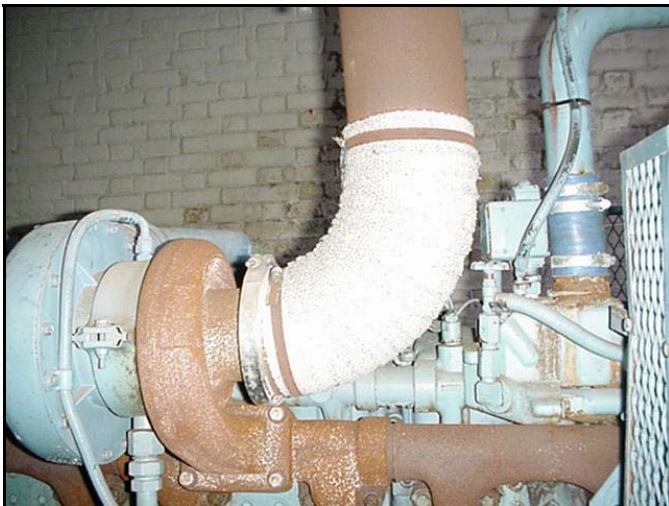
4.2 Asbestos cloth insulation

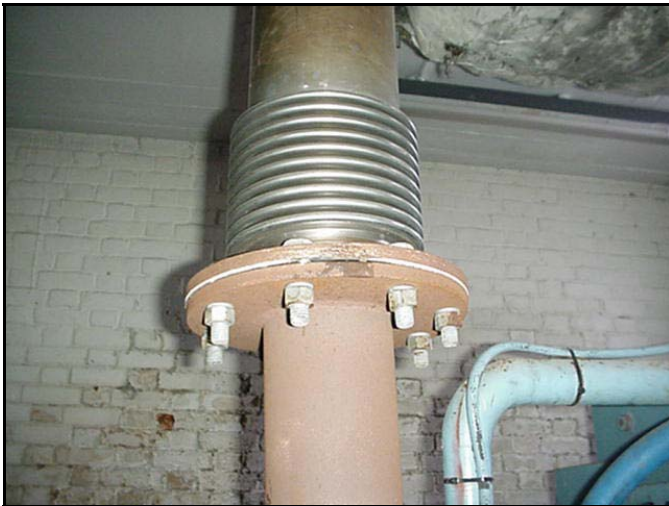
Sample No.	Photo ref.	Material Description	Material Extent	Analysis	Classification	Hazard	Comments & Recommendations
A65834/15	4.3	Gasket to Pipe Flange	1 m ²	Chrysotile	Ropes, yarns & cloths	C	This gasket is sealed in a good condition. Gaskets should be removed under controlled conditions as part of ongoing maintenance works and replaced with a non asbestos alternative.
A65835/16	4.2	Cloth Insulation	1 m ²	Chrysotile	Ropes, yarns & cloths	B	This cloth insulation is raw and friable. The cloth insulation should be removed under controlled conditions.

4.3 Asbestos gasket to pipe flange

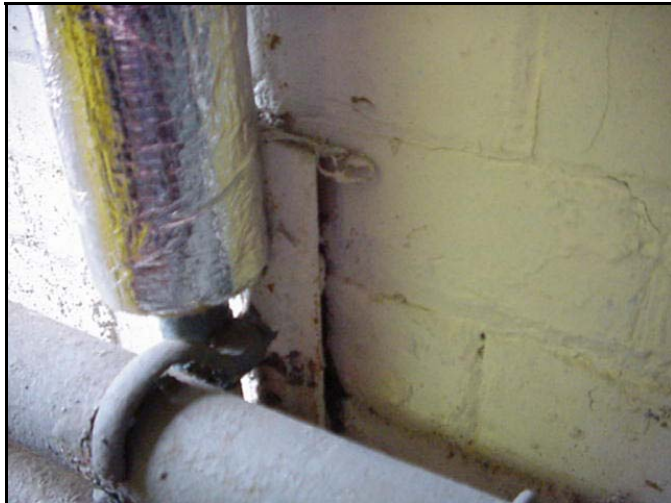
Sample No.	Photo ref.	Material Description	Material Extent	Analysis	Classification	Hazard	Comments & Recommendations
A65836/17	4.4	Insulation Residue Behind Bracket	1 m ²	Chrysotile	Insulation products	A	There was restricted access within the Plant Room due to hot works taking place. It should be assumed that asbestos residue is present to all surfaces until a further assessment is carried out. This residue is raw and friable. The insulation should be removed under controlled conditions. All walls should be thoroughly decontaminated.

4.4 Asbestos insulation residue behind bracket

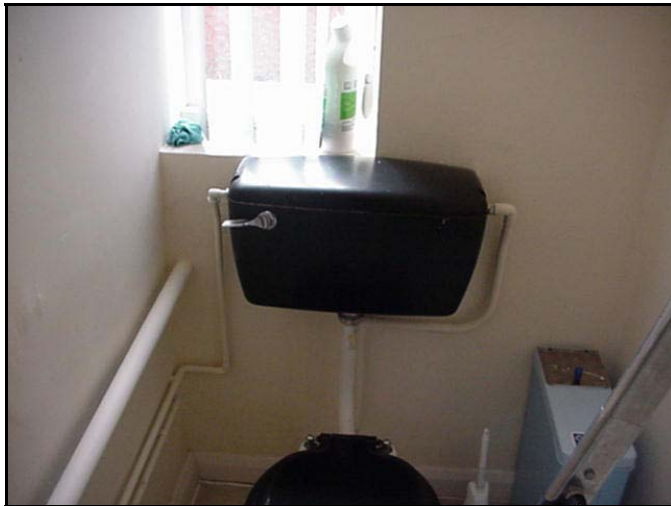
Sample No.	Photo ref.	Material Description	Material Extent	Analysis	Classification	Hazard	Comments & Recommendations
A65823/4	4.5	Toilet Cistern	1 m ²	Amosite	Plastics, resins, bitumens, mastics	C	This cistern is sealed in a good condition. The cistern should be labelled as asbestos to help prevent any accidental damage.

4.5 Asbestos toilet cistern
