Royal South Hants Hospital

Type 2 Asbestos Survey Report – Copy 1

November 2009

S-31559 / BI61109AW1 / Issue No. 2

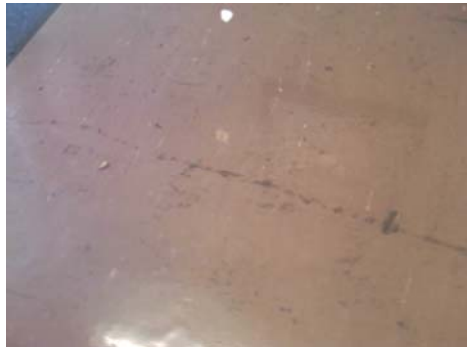
3.8.1.1 Location ID: LGI Entrance Lobby

Sample No.	Item Description	Item Extent	Comments / Observations / Recommendation			
A276563/002	Floor lino	8m²				
Analysis	Product Type		Hazard Risk Assessment			
NAD	N/A		Material Score		Priority Score

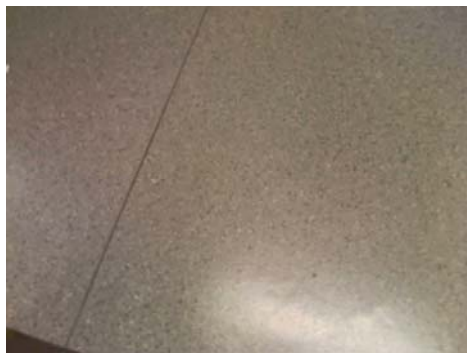
3.8.1.4 Location ID: LG19 Corridor

Sample No.	Item Description	Item Extent	Comments / Observations / Recommendation			
A276562/001	Floor lino	12m ²				
Analysis	Product Type		Hazard Risk Assessment			
NAD	N/A		Material Score		Priority Score

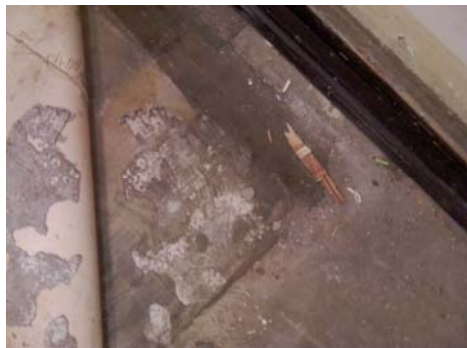
3.8.2.1 Location ID: G11 Residue on floor

Sample No.	Item Description	Item Extent	Comments / Observations / Recommendation			
A276567/006	Residue to floor	12m				
Analysis	Product Type		Hazard Risk Assessment			
NAD	N/A		Material Score		Priority Score

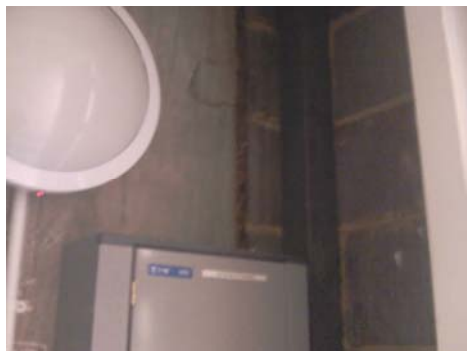
3.8.2.4 Location ID: G54a Riser

Sample No.	Item Description	Item Extent	Comments / Observations / Recommendation			
A276569/008	Expansion fillet	4m				
Analysis	Product Type		Hazard Risk Assessment			
NAD	N/A		Material Score		Priority Score

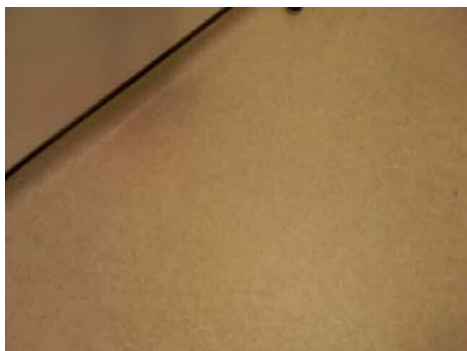
3.8.2.5 Location ID: G57 Staff Changing Room

Sample No.	Item Description	Item Extent	Comments / Observations / Recommendation			
A276588/027	Floor lino	20m ²				
Analysis	Product Type		Hazard Risk Assessment			
NAD	N/A		Material Score		Priority Score

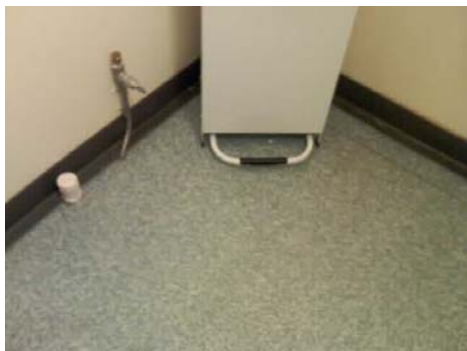
3.8.2.6 Location ID: G60 Staff Changing Room

Sample No.	Item Description	Item Extent	Comments / Observations / Recommendation			
A276589/028	Floor lino	2m ²				
Analysis	Product Type		Hazard Risk Assessment			
NAD	N/A		Material Score		Priority Score

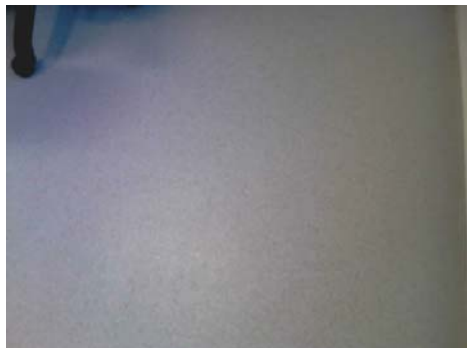
3.8.5.1 Location ID: 2.12 Treatment Room

Sample No.	Item Description	Item Extent	Comments / Observations / Recommendation			
A276572/011	Floor lino	16m²				
Analysis	Product Type		Hazard Risk Assessment			
NAD	N/A		Material Score		Priority Score

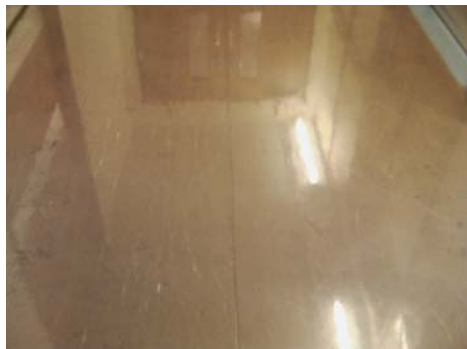
3.8.5.5 Location ID: 2.25 Corridor

Sample No.	Item Description	Item Extent	Comments / Observations / Recommendation			
A276585/024	Floor lino	30m²				
Analysis	Product Type		Hazard Risk Assessment			
NAD	N/A		Material Score		Priority Score

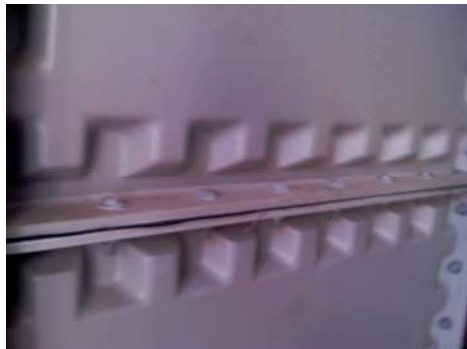
3.8.6.2 Location ID: R3 Tank Room

Sample No.	Item Description	Item Extent	Comments / Observations / Recommendation			
A276573/012	Mastic to water tank	20m				
Analysis	Product Type		Hazard Risk Assessment			
NAD	N/A		Material Score		Priority Score

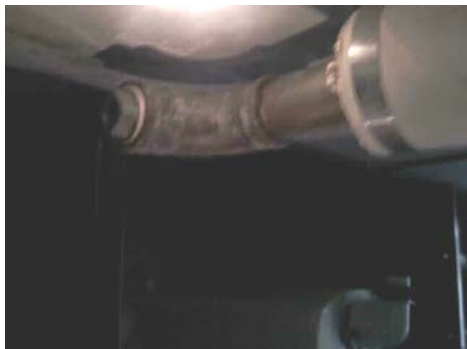
3.9.1.1 Location ID: 001 Basement

Sample No.	Item Description	Item Extent	Comments / Observations / Recommendation			
A276772/032	Residue to pipe	0.2m²				
Analysis	Product Type		Hazard Risk Assessment			
NAD	N/A		Material Score		Priority Score

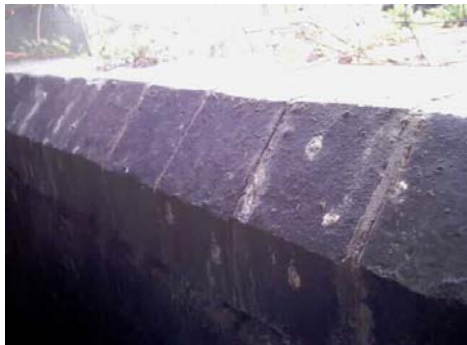
3.9.1.2 Location ID: 002 Basement

Sample No.	Item Description	Item Extent	Comments / Observations / Recommendation			
A276774/034	Residue to wall	1m ²				
Analysis	Product Type		Hazard Risk Assessment			
NAD	N/A		Material Score		Priority Score

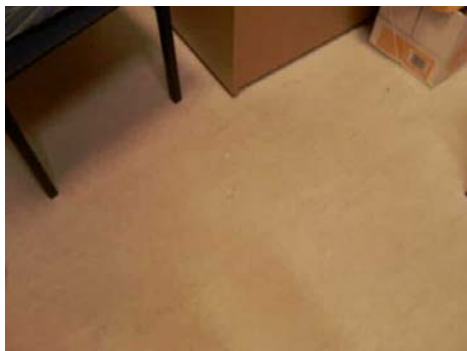
3.9.2.2 Location ID: 009 Office

Sample No.	Item Description	Item Extent	Comments / Observations / Recommendation			
A276999/041	Floor lino	6m²				
Analysis	Product Type		Hazard Risk Assessment			
NAD	N/A		Material Score		Priority Score

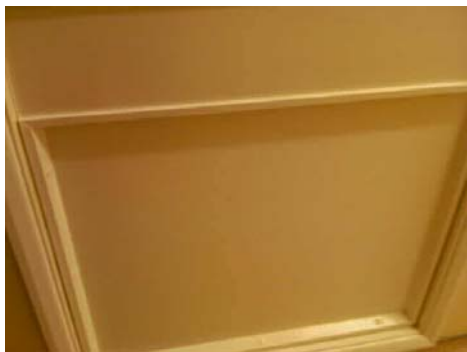
3.9.2.3 Location ID: 014 Office

Sample No.	Item Description	Item Extent	Comments / Observations / Recommendation			
A276997/039	Panel beneath window	1m ²				
Analysis	Product Type		Hazard Risk Assessment			
NAD	N/A		Material Score		Priority Score

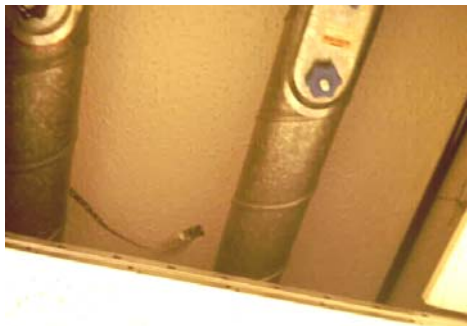
3.9.3.1 Location ID: 005 Disposal

Sample No.	Item Description	Item Extent	Comments / Observations / Recommendation			
A276995/037	Textured coating to ceiling	6m²				
Analysis	Product Type		Hazard Risk Assessment			
NAD	N/A		Material Score		Priority Score

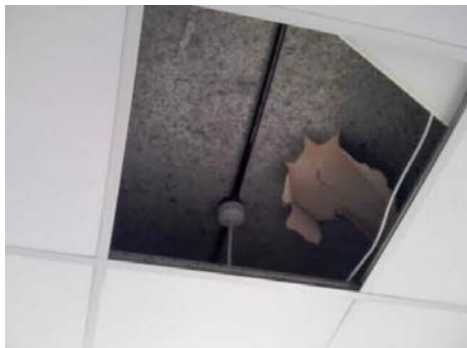
3.9.4.1 Location ID: 001 Corridor

Sample No.	Item Description	Item Extent	Comments / Observations / Recommendation			
A276770/030	Paper to ceiling	15m²				
Analysis	Product Type		Hazard Risk Assessment			
NAD	N/A		Material Score		Priority Score

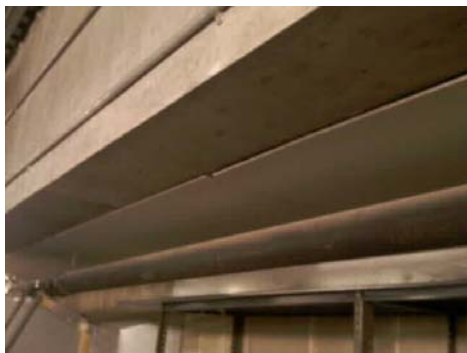
3.10.5.42 Location ID: 388 Plant Room

Sample No.	Item Description	Item Extent	Comments / Observations / Recommendation			
A276586/025	Ceiling panels	15m ²				
Analysis	Product Type		Hazard Risk Assessment			
NAD	N/A		Material Score		Priority Score

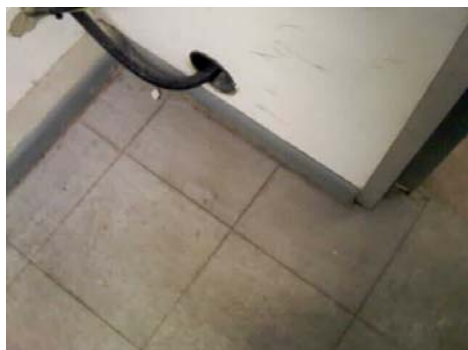
3.10.6.1 Location ID: 003 Server Room

Sample No.	Item Description	Item Extent	Comments / Observations / Recommendation			
A276771/031	Floor tiles	10m ²				
Analysis	Product Type		Hazard Risk Assessment			
NAD	N/A		Material Score		Priority Score

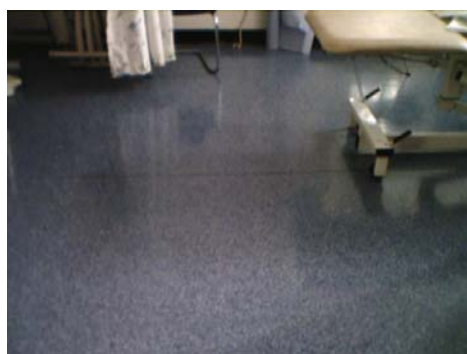
3.11.1.1 Location ID: 001 Room 6

Sample No.	Item Description	Item Extent	Comments / Observations / Recommendation			
CF4334/047	Floor lino	25m ²				
Analysis	Product Type		Hazard Risk Assessment			
NAD	N/A		Material Score		Priority Score

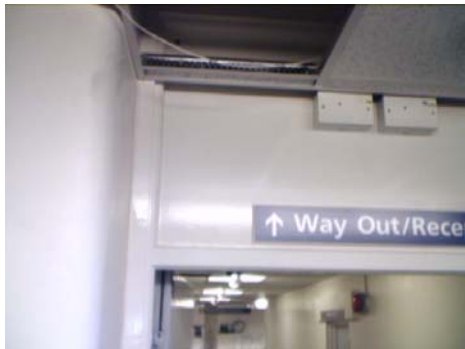
3.1.1.2 Location ID: 004 Corridor

Sample No.	Item Description	Item Extent	Comments / Observations / Recommendation			
CF4335/048	Fire break	4m²				
Analysis	Product Type		Hazard Risk Assessment			
NAD	N/A		Material Score		Priority Score
